Smart Composite Pressure Vessels (SCPV) with Integrated Health Monitoring

Steelhead Composites,

Date: April 2020

Final Technical Report

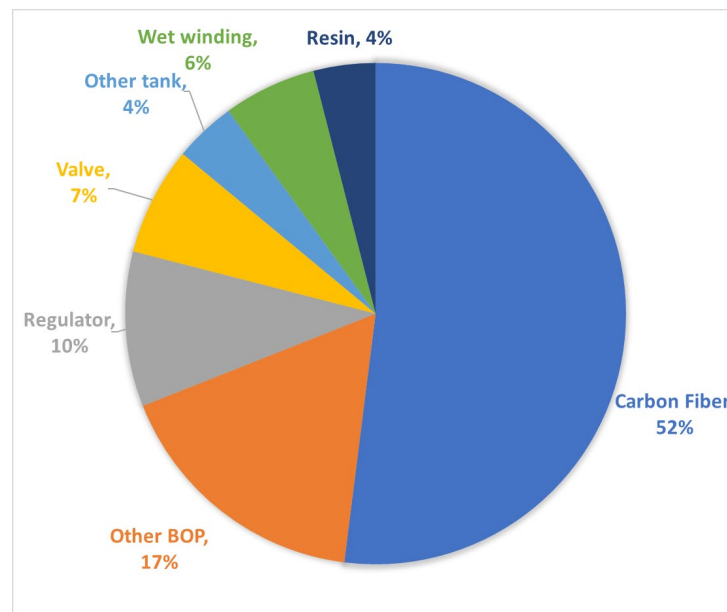
FIGURE 2: COST BREAKDOWN IN A H2 STORAGE FOR HIGH VOLUME PRODUCTION

strength carbon fiber products are far too expensive to meet DOE goals for storage system costs. The cost of carbon fiber alone constitutes over 50% of the total cost of the pressure vessel. For example, a recent analysis of the costs for 700 bar hydrogen storage systems for light-duty vehicles indicated that at an annual manufacturing rate of 100,000 systems per year, the CF accounts for approximately 52% of the total system cost of \$16/kWh of hydrogen (Figure 2) [4]. Most composite pressure vessels are designed to regulatory standards that mandate safety factors against burst, stress rupture, pressure cycles, impact damage and flaw tolerance. These safety factors have lineage to the aerospace heritage of composite pressure vessels with low burst factor (1.5 – 2x) and low fatigue cycles (100-1000s). The safety factors have not been critically fine-tuned for higher burst factor (2.25 – 3x) and high fatigue cycle application (20,000 -100,000s) of automotive or transportation industry. The safety (burst) factors referred to in the design standards for the latter applications also assume manufacturing variability, workmanship and damage tolerance not inherently included in the design. Real time monitoring of the structural health is sought to minimize the padded safety factors without sacrificing the safety of the vessels.

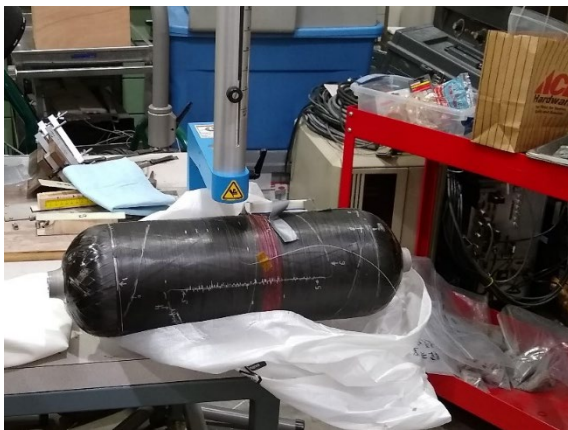
Figure 4(a) shows the experimental set-up at of the drop impact test on a composite pressure vessel at University of Tennessee. Figure 4(b) shows the 3D finite element model created by Steelhead Composites to simulate the drop impact test. The model uses a Type 3 vessel construction with 6061-T6 Aluminum liner with composite overwrap designed for 350 bar H₂ storage. A full elastic-plastic material behavior is assumed for the Aluminum. The composite overwrap consists of multiple plies of unidirectional composite arranged in specific order and with varying angles of orientation relative to the vessel axis that represent the filament wound layers of construction. In addition to the individual plies, the composite shell also incorporates interlaminar plies modeled using cohesive layers inserted between the individual filament wound layers.

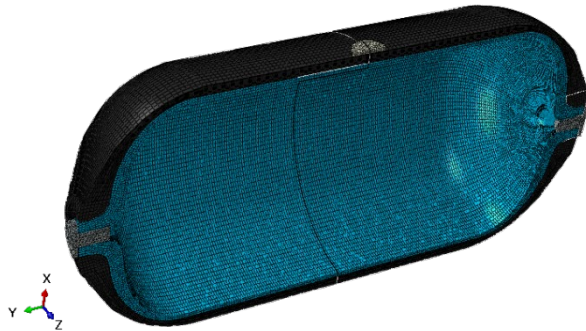
FIGURE 4: 3D FINITE ELEMENT MODEL OF AN 80 L DESIGNED FOR 5000 PSI H₂ STORAGE

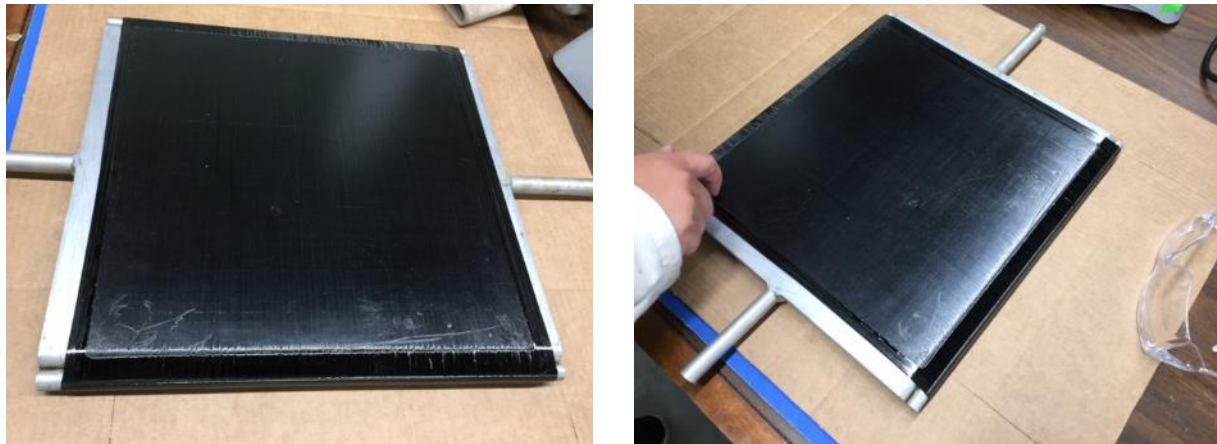
FIGURE 6: FLAT PANELS OF UNIDIRECTIONAL COMPOSITE FABRICATED BY ORNL USING FILAMENT WINDING ON A FLAT PADDLE

ORNL fabricated unidirectional flat panels using the filament winding method on a flat paddle mandrel as shown in Figure 6. The panels used ITS50-24K carbon fiber towpregs provided by Teijin Carbon America (Figure 7). The winding and consolidation/curing conditions were selected in order to match as closely as possible the cylinder production parameters when producing the test panels. The winding advance for the panels was set at 4 mm/revolution (0.157 in/rev) in order to match the nominal towpreg width and anticipated nominal advance to be used in test tank production. Targeted panel thickness was about 1 mm (0.040 in) for fiber-directional test coupons and about 2 mm (0.080 in) for transverse-directional testing. To attain these thicknesses, 3 passes (1-1/2 complete circuits) were utilized for the 1 mm panels and 6 passes (3 complete circuits) were utilized for the 2mm panels. The panels were wound at room temperature, which was about 18 °C (65 °F) in the laboratory at the time the panels were produced. The panels were wound with about 67 N (15 lbs.) tow tension without wiping, scraping, or other consolidation aids employed. After winding, the panels (on the mandrel) were transported to a laboratory press for cure at relatively low pressure. The panels were sandwiched between mold-released aluminum caul plates and pressurized to 2 tons, representing less than 15 lbs. per square inch. Temperature was ramped to 85 °C (185 °F) and held for 1 hour and then ramped to 149 °C (300 °F) for another 1 hour dwell. After curing, the press and panel were allowed to gradually cool to room temperature overnight before being cut and removed from the mandrel for testing. Panels labeled as SH2 A and B were the two sides of the 1 mm fabrication while SH3 A and B were from the 2 mm fabrication. The processing parameters are summarized in Table 1.

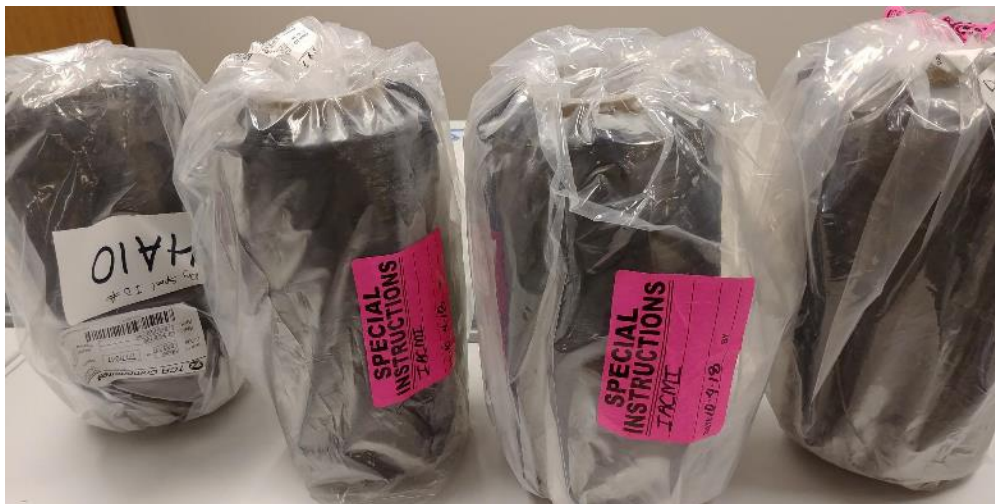
FIGURE 7: TOWPREGS WITH ITS50-24K CARBON FIBER SUPPLIED BY TEIJIN CARBON AMERICA

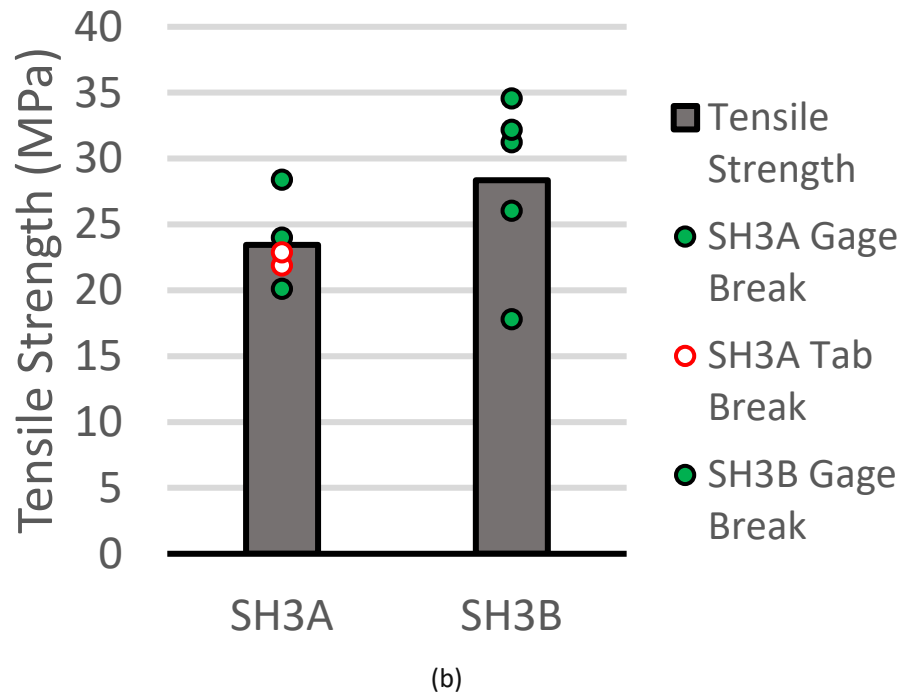
FIGURE 9: AVERAGED AND INDIVIDUAL TENSILE STRENGTH VALUES FOR THE FIBER-DIRECTION (A) AND TRANSVERSE-DIRECTION (B) PLATES. NOTE THAT THE COLOR OF THE INDIVIDUAL SAMPLE MARKER DENOTES THE FAILURE MODE OF THE SAMPLE

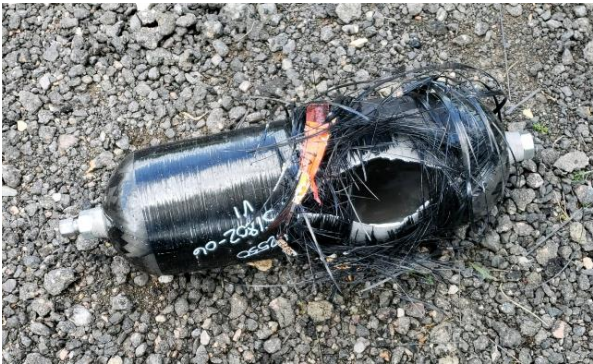
FIGURE 12: CYLINDRICAL BURST MODE IN A STEB VESSEL SUBJECTED TO A HYDROSTATIC BURST TEST

Subsequent to coupon testing, 150 mm (6 in. dia.) x 460 mm (18 in.) long standard test and evaluation bottles (STEBs) were fabricated by filament winding ITS50-24K towpreg over Aluminum liners. The composite overwrap in the STEB consists of 2 helicals and 2 hoop plies. The material properties of the composite plies determined in coupon testing were used to ensure that the failure mode in STEB is due to hoop stresses in the cylindrical section. The rupture mode of the STEB validated this design projection (Figure 12). Five (5) STEBs were fabricated altogether in the exact same way and burst tested. The burst results are summarized in Figure 13. The test results show good, consistent performance of ITS50-24K fiber within the allowable manufacturing variation.

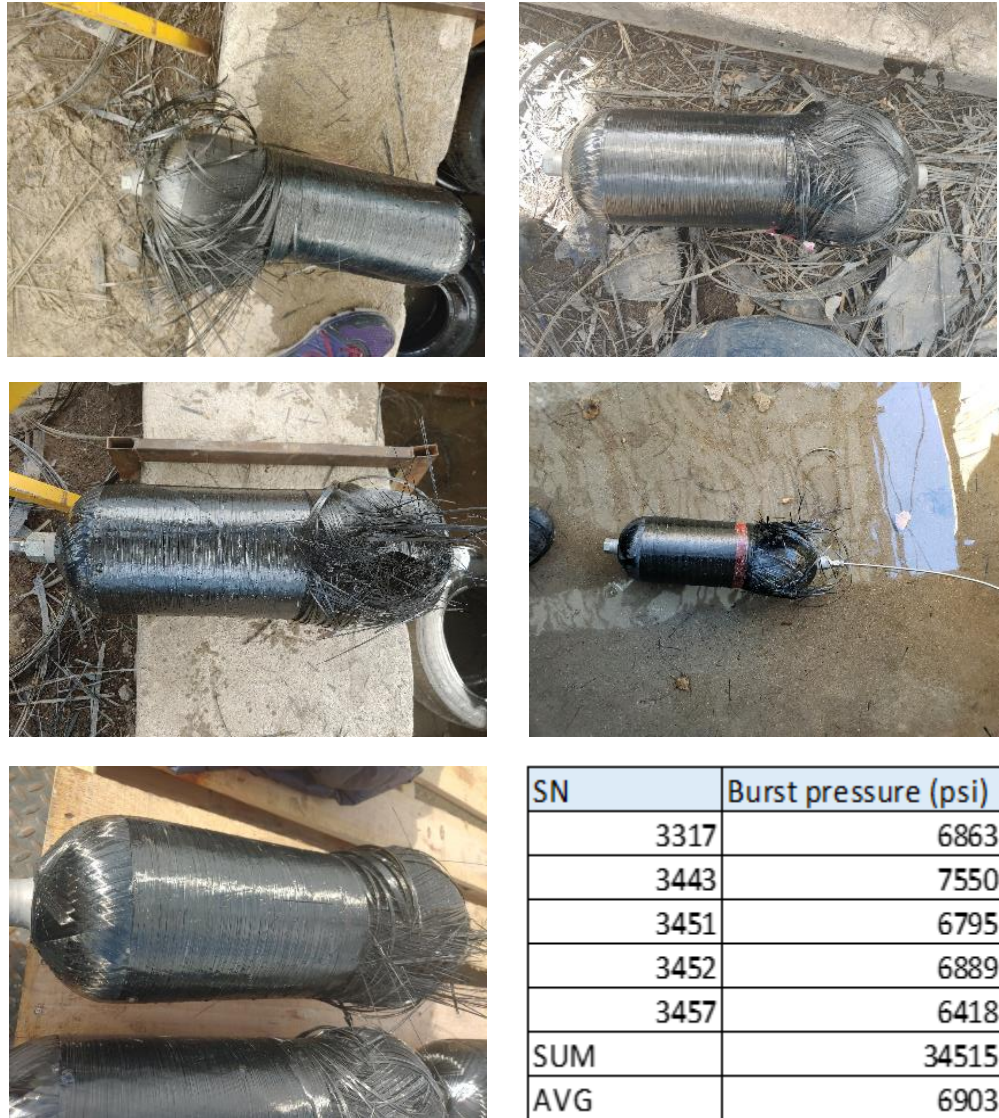
FIGURE 13: BURST TEST PICTURES OF STEBS FABRICATED WITH TEIJIN ITS5-24K AND A SUMMARY OF BURST TEST RESULTS

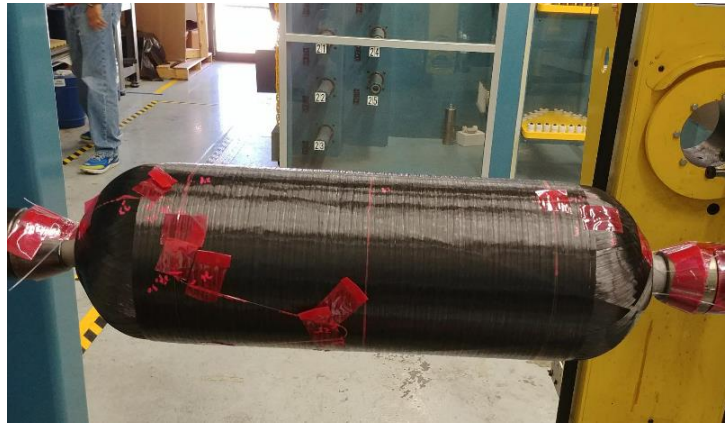
FIGURE 17: STEB WITH FIBER OPTIC SENSORS AT THE END OF FABRICATION

Figure 14 and Figure 15 show the paths of the HD-DFOSs as planned for integration in a STEB. The path shown in Figure 14 was chosen to give a full picture of the strain state, to include strains in the hoop and axial directions, as well as the strains in the direction of the helix wraps. A template was made to assist in accurately placing the fiber (Figure 16(a)). The path in Figure 15 was chosen with the goal of detecting damage within the composite overwrap and only looks at strains along the hoop and axial direction. In both cases, strain measurements were limited to the cylindrical section of the vessels. Strain was measured in both vessels using an ODISI 6 interrogator (LUNA Innovations) with remote modules (Figure 16 (b)). All of the vessels in this study were wound using a McClean-Anderson Spider. Figure 17 shows the STEB after winding.

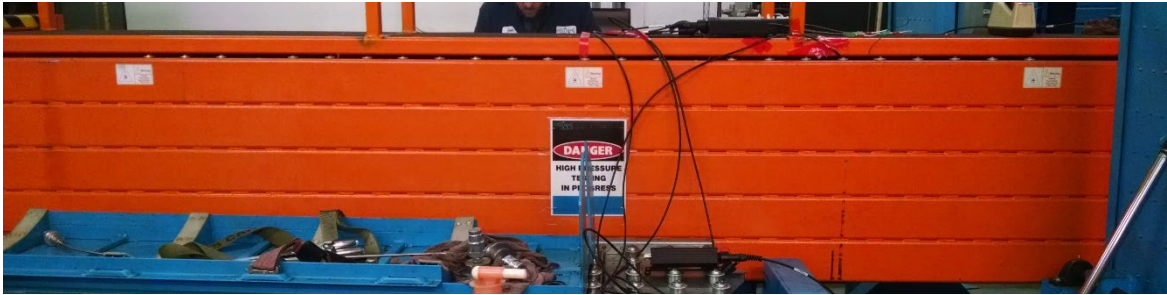
FIGURE 20: PRESSURIZATION CHAMBER WITH RAISED BLAST DOORS

Once the STEB was wound and cured, it was filled with automatic transmission fluid, placed in a testing chamber with blast doors, and connected to a pressurization unit for autofrettage and step pressurization (Figure 20). After the vessel with embedded sensors was autofrettaged, it was pressurized in steps from 500 psig to 3,000 psig in increments of 500 psig. Excellent correlation was observed between the fiber optic sensor data and the mechanical strain gages on the outermost layer of the vessel (Figure 21).

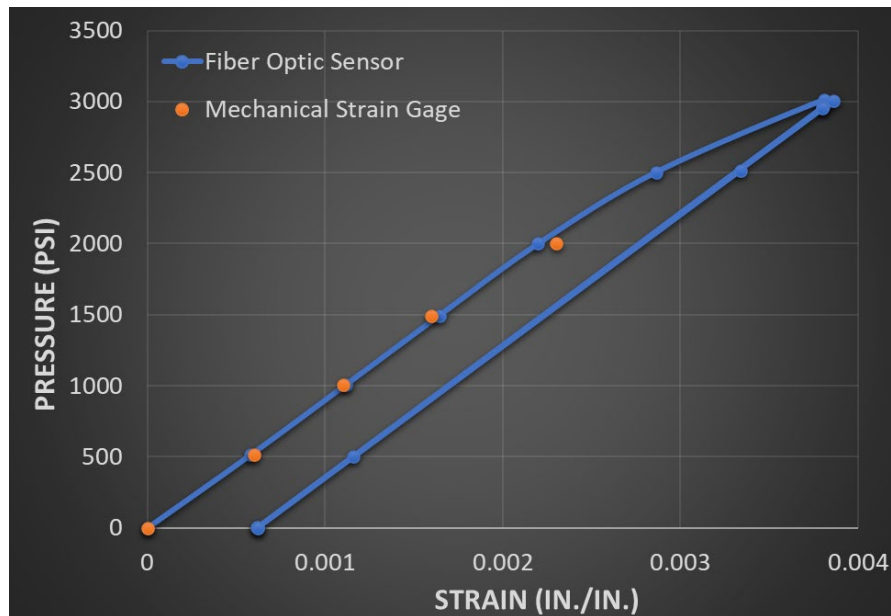
FIGURE 21: CORRELATION OF FOS AND MECHANICAL STRAIN GAGE PLOT OF PRESSURE VS STRAIN AS DETERMINED FROM HYDROSTATIC PRESSURIZATION OF A STEB

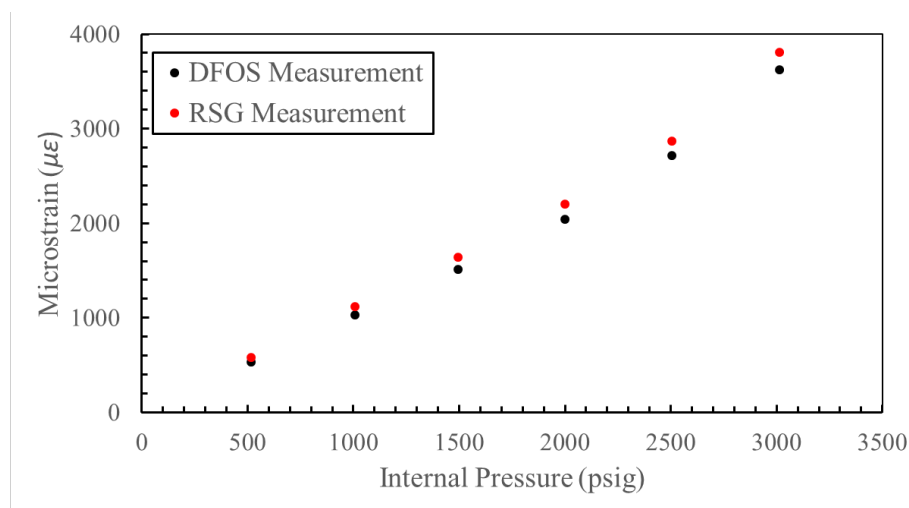
FIGURE 25: COMPARISON BETWEEN STRAINS MEASURED BY A RESISTIVE STRAIN GAGE (RSG) AND THE AVERAGE OF THE STRAIN MEASURED BY THE DISTRIBUTED FIBER OPTIC SENSOR (DFOS) ALONG THE MIDDLE HOOP SEGMENT (HOOP 2)

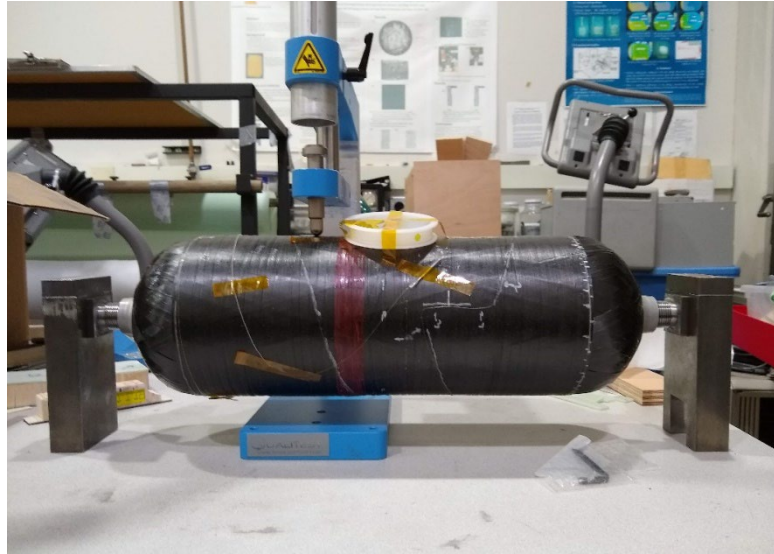
FIGURE 28: IMPACT TESTING SETUP

To investigate the ability of the HD-DFOSs to capture low velocity impact damage, a STEB with embedded sensors was impacted at the same location at increasingly higher impact energies. This was performed with a Gardner impact testing platform by dropping a 3.6 kgs (8 lbs.) mass through a guide tube and striking a tup (falling weight) with 12.5 mm (0.5 in.) diameter hemispherical end (Figure 28). Strain measurements from the HD-DFOS were supplemented with fiber Bragg grating sensors (FBGs) and digital image correlation (DIC). Two FBGs with 10 mm gage lengths were supplied by LUNA Innovations (formerly a product of Micron Optics), and these were used with a HYPERION si155 interrogator. The FBGs were included because they can acquire data at much faster rates than the HD-DFOSs. The slower acquisition rate of the HD-DFOSs is, in fact, a direct consequence of their high spatial resolution, and measurements will not register during the impact. Strain data during impact will provide data that can be used to refine FEA modeling. One sensor was placed adjacent to the impact site, and one sensor was placed directly opposite the impact site on the vessel's underside.

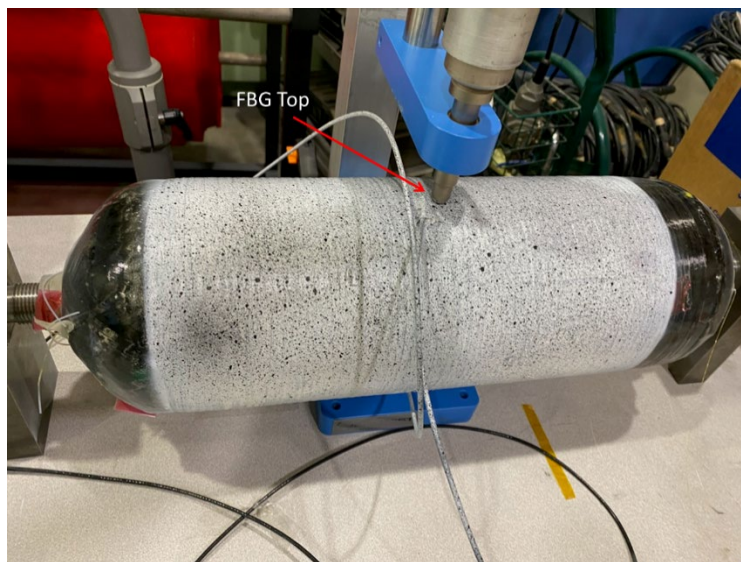
**FIGURE 29: PICTURE OF THE IMPACT SITE AND THE FBG BOUND TO THE TOP OF THE VESSEL, ADJACENT TO THE IMPACT SITE.
NOTE THAT THE FBG IS ORIENTED TO MEASURE HOOP-DIRECTION STRAIN**

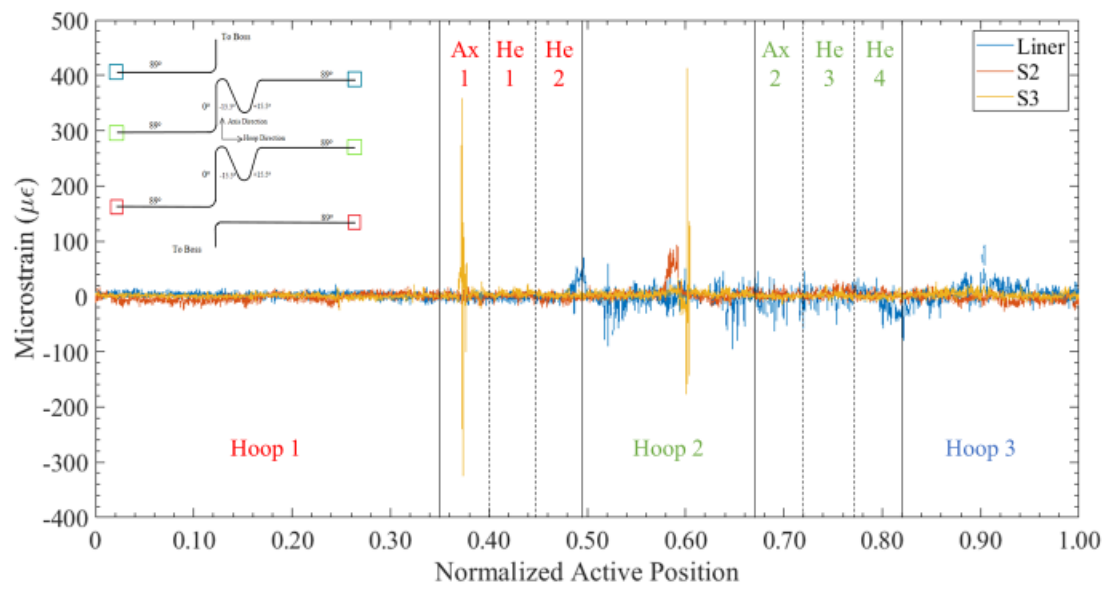
FIGURE 31: STRAIN PROFILE IN THE STEB WITH EMBEDDED SENSORS AFTER THE 5 J IMPACT AND PHYSICAL LOCATION OF IMPACT SITE ON VESSEL

Strain measured by each of the HD-DFOSs after the initial and final impacts are shown in Figure 31 and Figure 32, respectively. Although small, the strain at the impact site is clearly observed below the surface of the overwrap. Note that the damage locations do not line up because the sensors are not precisely aligned, not necessarily because the damage is distributed at different locations within each wrap. Although Fig. 31 shows the impact location relative to the HD-DFOS layout relative to the surface sensor, note that no data is reported for the surface sensor. That sensor was broken during the setup of the experiment. The impact site was located near the second hoop-oriented segment because, although the sensors could not be precisely aligned the position of the second hoop segment of each sensor was deemed to be the most consistent between layers.

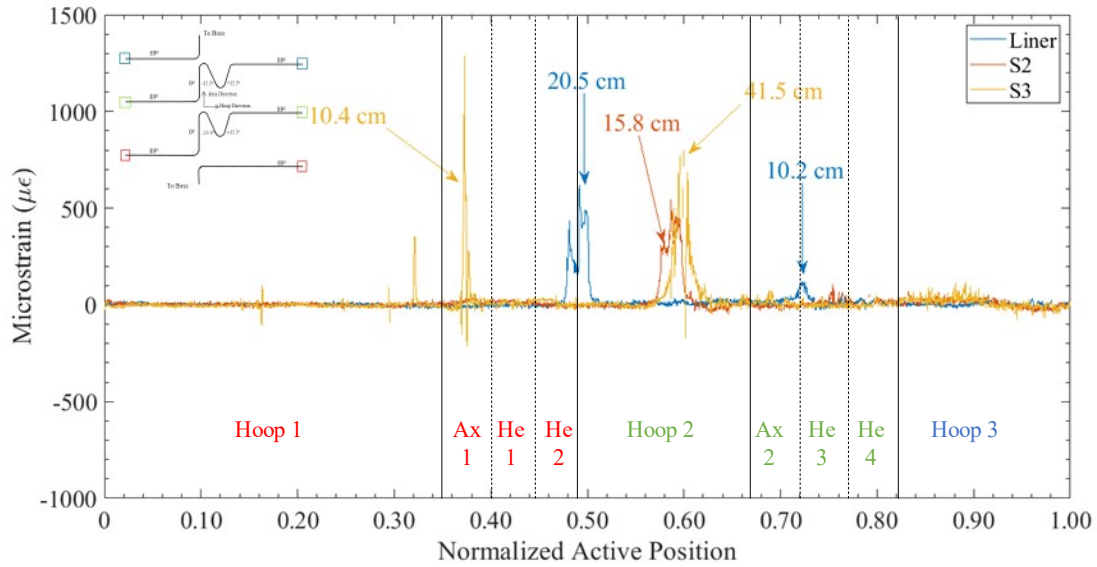
FIGURE 32: STRAIN PROFILE IN THE STEB WITH EMBEDDED SENSORS AFTER ALL IMPACTS. NUMBERS INDICATE THE WIDTH OF THE PEAK

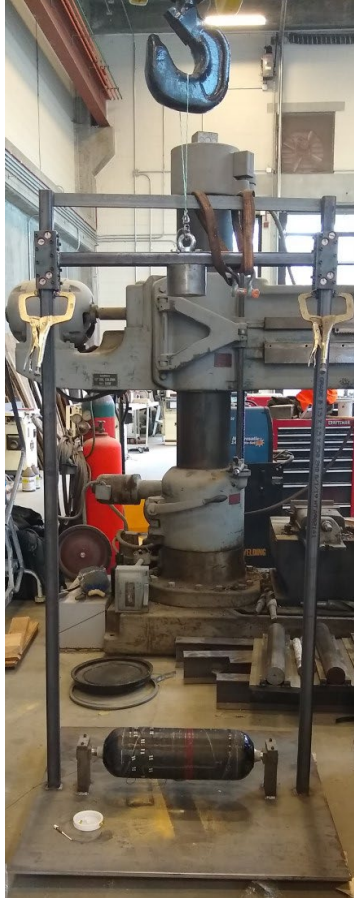
FIGURE 40: HEAVY IMPACT FRAME

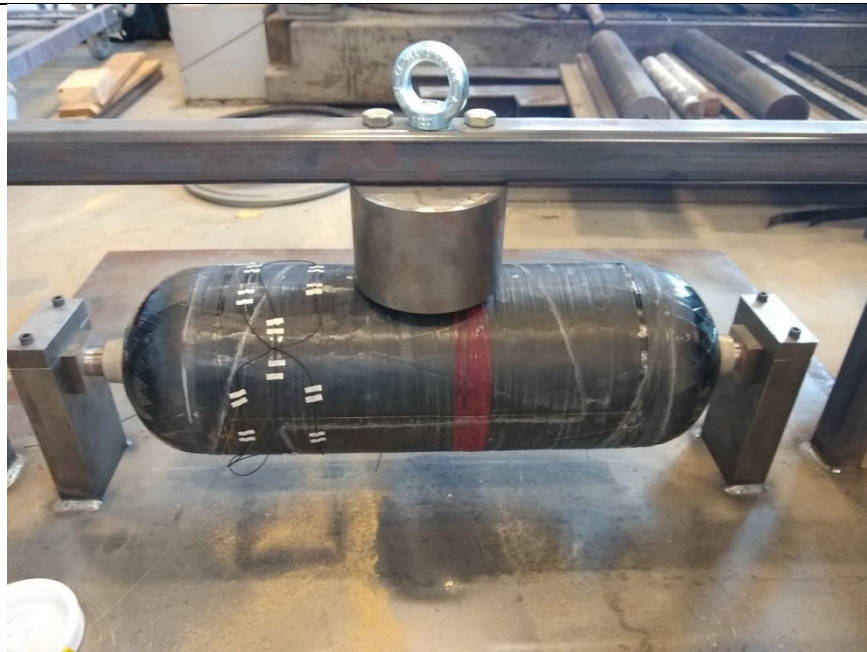
FIGURE 41: STEB USED IN THE HEAVY IMPACT TEST

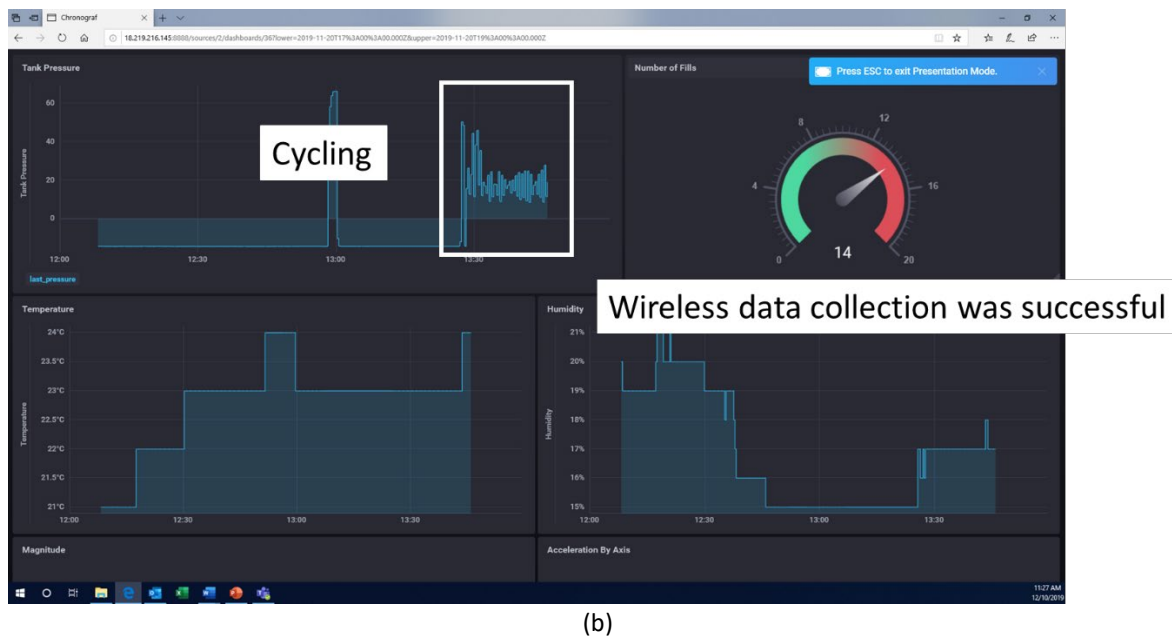
FIGURE 45: READOUTS OF DATA RECORDED BY THE WIRELESS MEASUREMENT DEVICE. PRESSURIZATION DURING THE AUTOFRETTAGE AND BURST OF ONE VESSEL IS SHOWN ON (A), AND THE PRESSURE OSCILLATIONS FROM THE PRESSURE CYCLING OF THE OTHER VESSEL IS SHOWN IN (B)

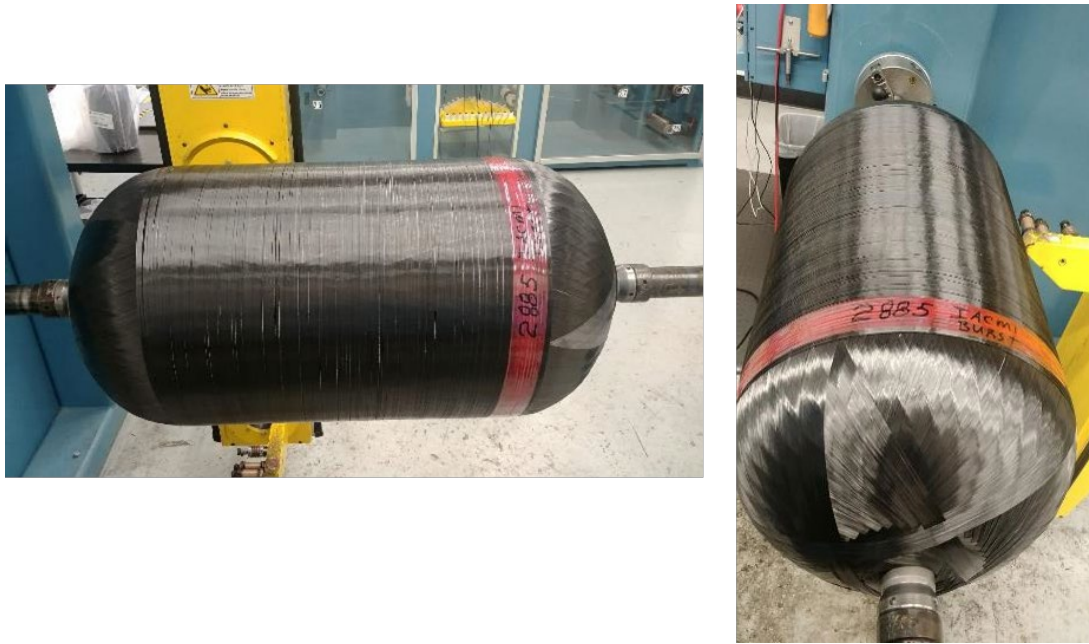
FIGURE 47: A 80 L VESSEL PRODUCED FOR VERIFICATION OF BURST PRESSURE

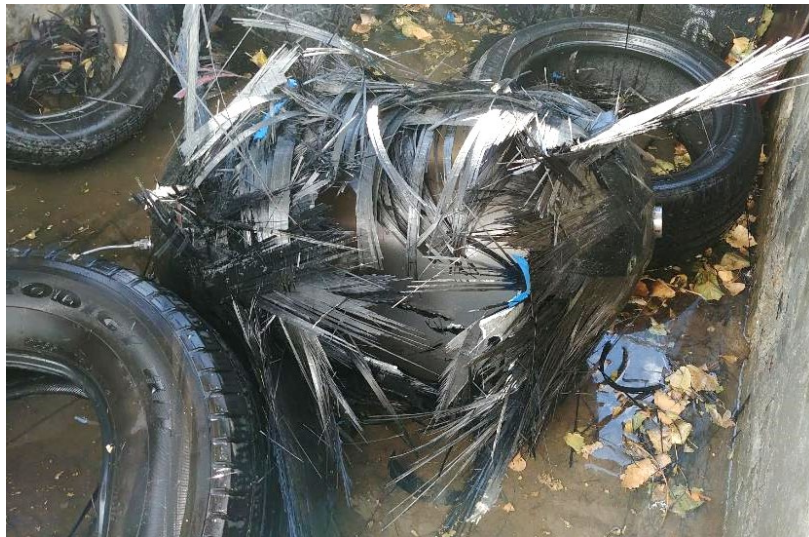
FIGURE 48: A 80L VESSEL (SN 2885) AFTER BURST TEST

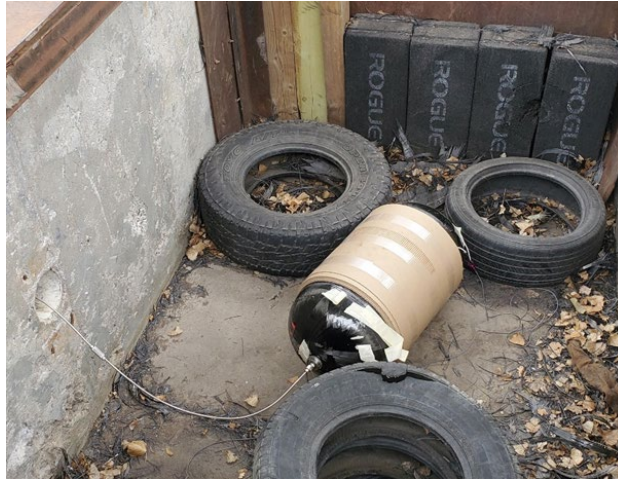
FIGURE 57: A FULL SIZE COMPOSITE PRESSURE VESSEL IN THE BURST PIT

One of the full scale vessels with the HD-DFOS bound to the surface, was filled with water, and taken to the burst testing pit and pressurized hydrostatically to burst (Figure 57).
